# **HYDRAULIC MODELING AND GEOMORPHIC ANALYSIS OF SACRAMENTO RIVER, RM 184 TO RM 194 GLENN AND BUTTE COUNTIES, CALIFORNIA**

**April 26, 2002**

2151 River Plaza Dr. Suite 170  
Sacramento, California 95833  
Voice 916.563.7700, FAX 916.563.6972  
Ayres Associates Project Number 33.0134.00

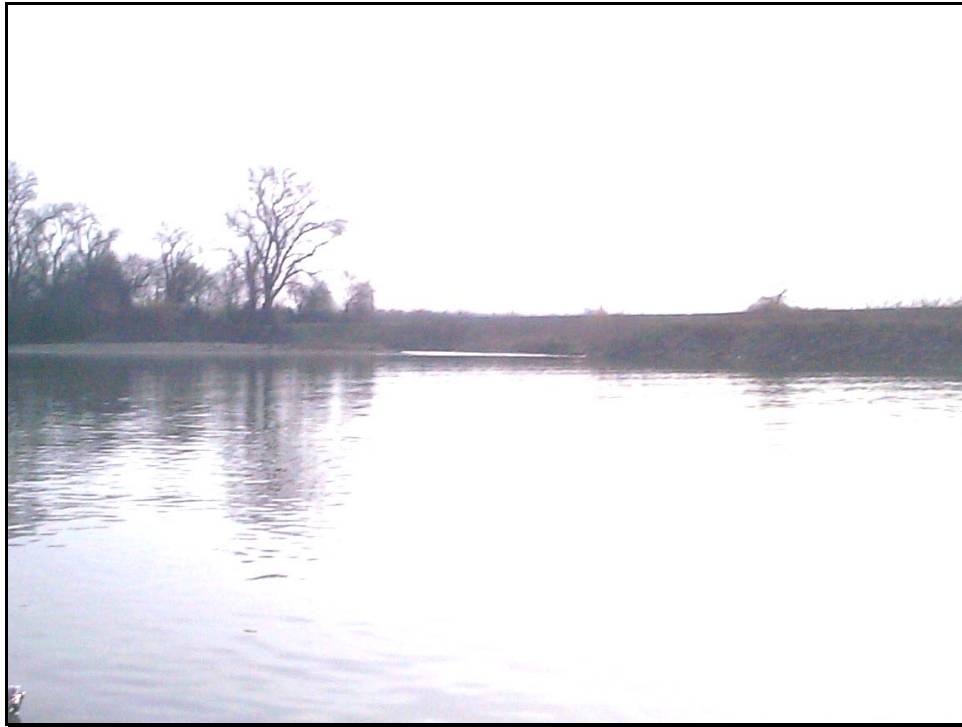
The following photographs show the areas of the river where the 1995 and the modeled cutoff are located. **Photograph 1** is looking downstream with the Road 29 levee and bank protection located on the right side of the photograph. This area is where the modeled breach would begin. **Photograph 2** is looking south from Road 29 and shows the modeled cutoff path across Kimmelshue Bend. **Photograph 3** is a view looking north across the Sacramento River at the location where the modeled cutoff would re-enter the river.

**Photograph 1.** Looking Downstream along the Sacramento River with the Road 29 Embankment along the Right Side (RM 188.0)

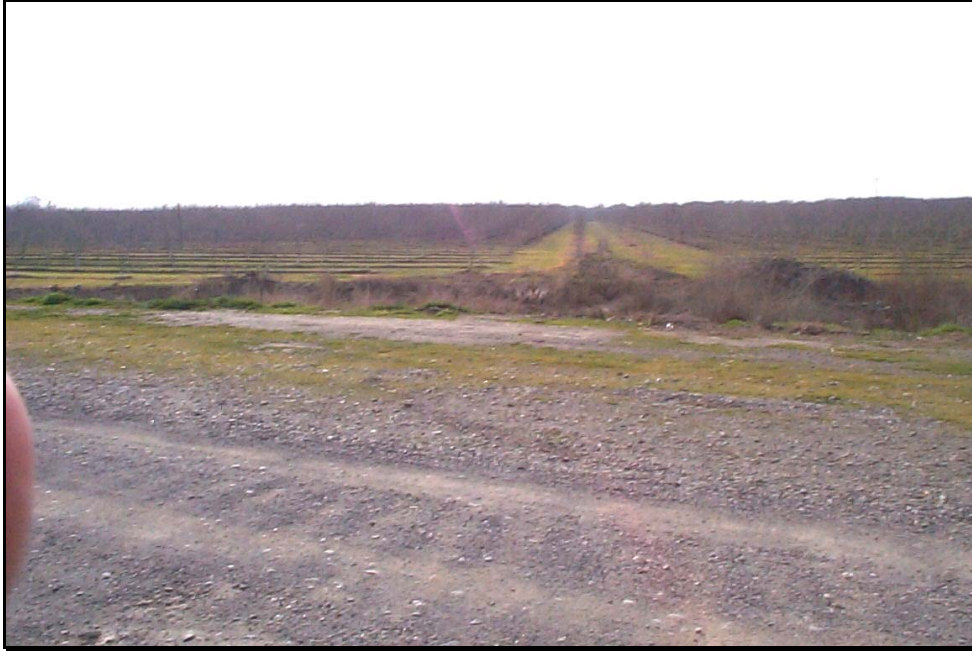
**Photograph 2.** Looking South from Road 29 at Modeled Cutoff Location

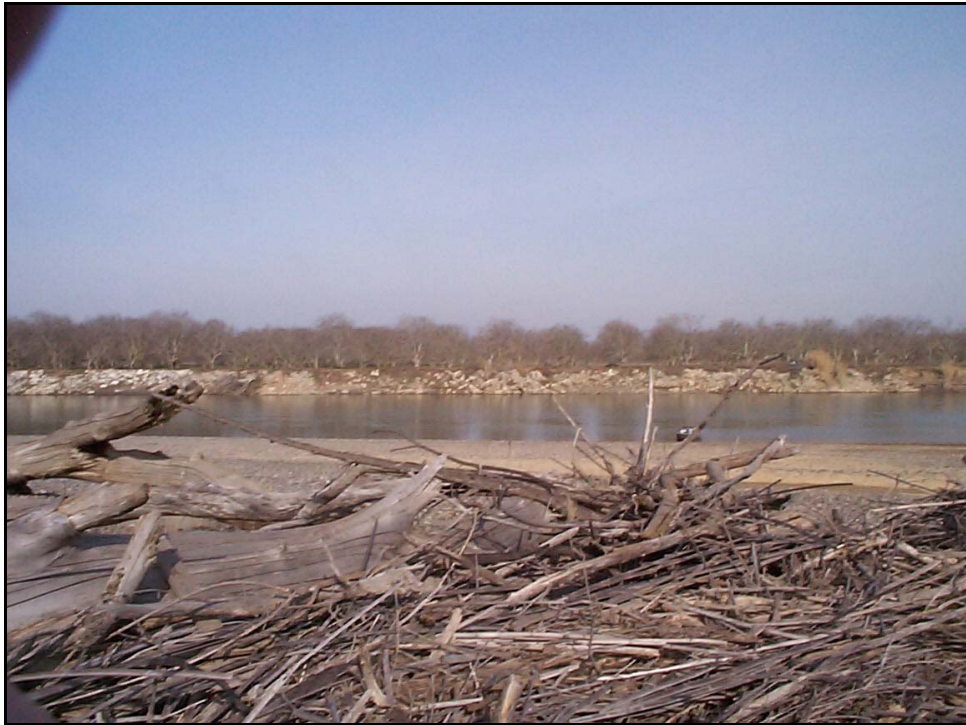
**Photograph 3.** Looking North at the Modeled Re-entry Point for Cutoff Channel.  
River Flow is Right to Left in the Photograph
